Masonry & Steel Restoration FE Bellows Elementary School

Summer 2019

Lintel repairs at the FE Bellows School

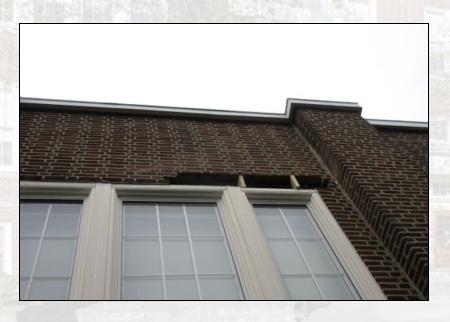
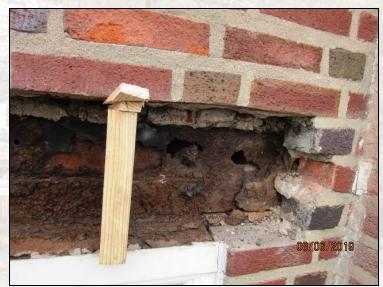
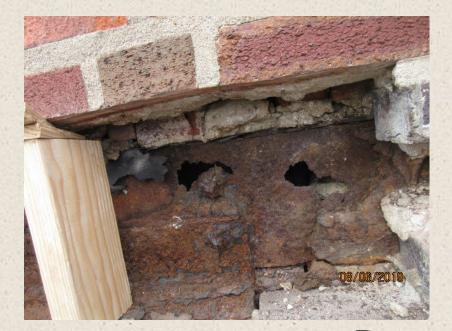
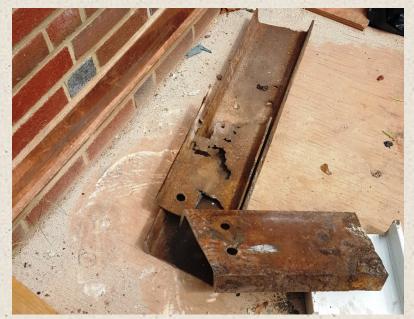
Brick removal and masonry restoration at the FE Bellows Elementary School revealed rust corrosion to the "C" channel lintels above the auditorium windows

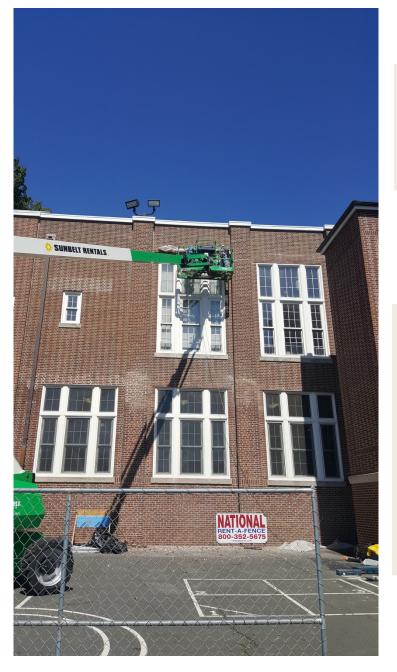
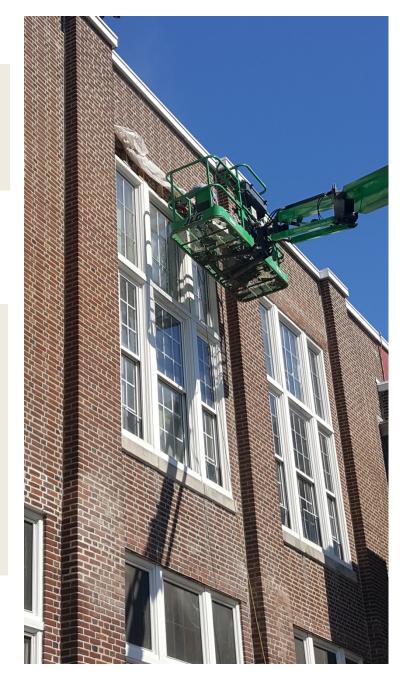
Work commences on the second lintel repair

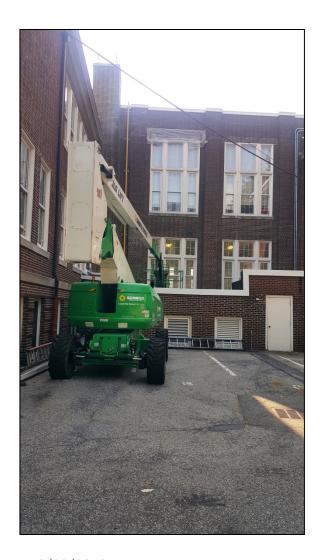
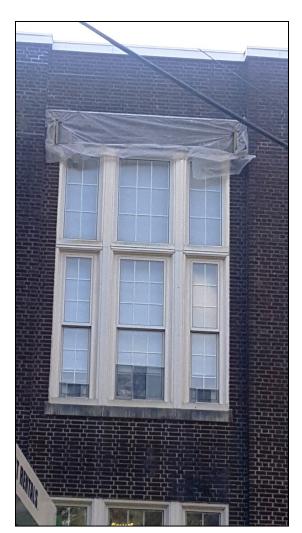
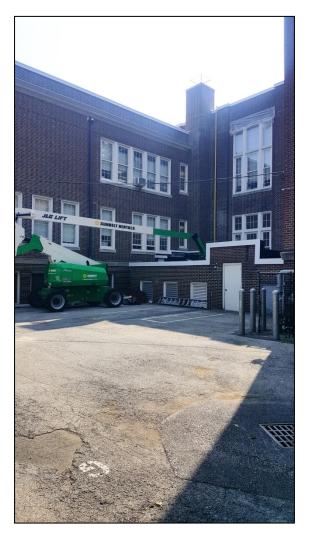
Repair is in progress at the driveway side of the FEB auditorium - more deteriorated structural steel lintels discovered on window areas #3.
